November 17, 2020

# 505 WEST CHAPEL HILL ST EXISTING BUILDING ANALYSIS

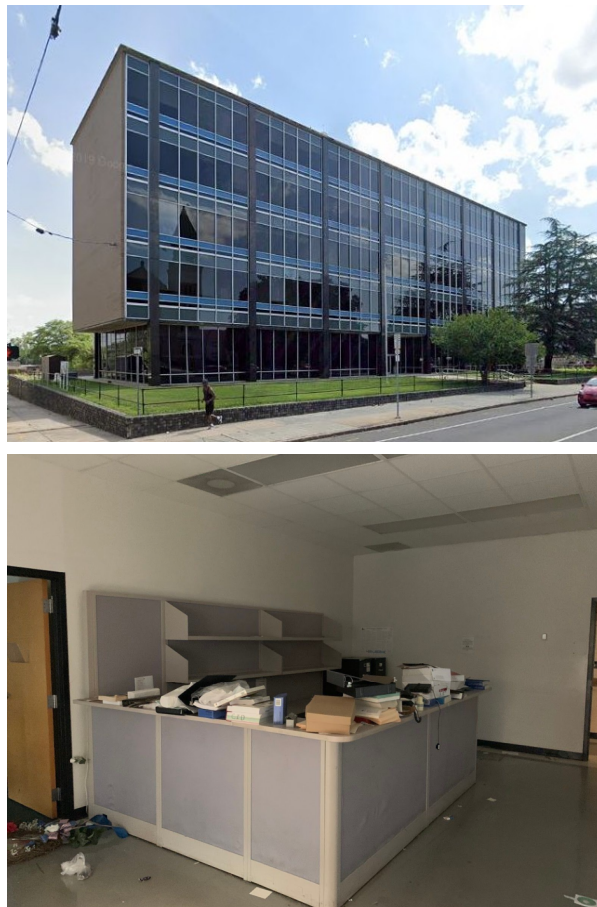
Google Earth Street View (Above), Typical Office Environment and Condition of the Building (Below)

At 64 years old, the building's condition has deteriorated. The last significant study of the building was the exterior in 2012. A lack of moisture management has had significant impacts on the building's facades. Concerning the building interior, code mandated egress requirements are the key consideration driving future design considerations and once the interior partitions are removed, much of the building's original key features will no longer have to be imagined.

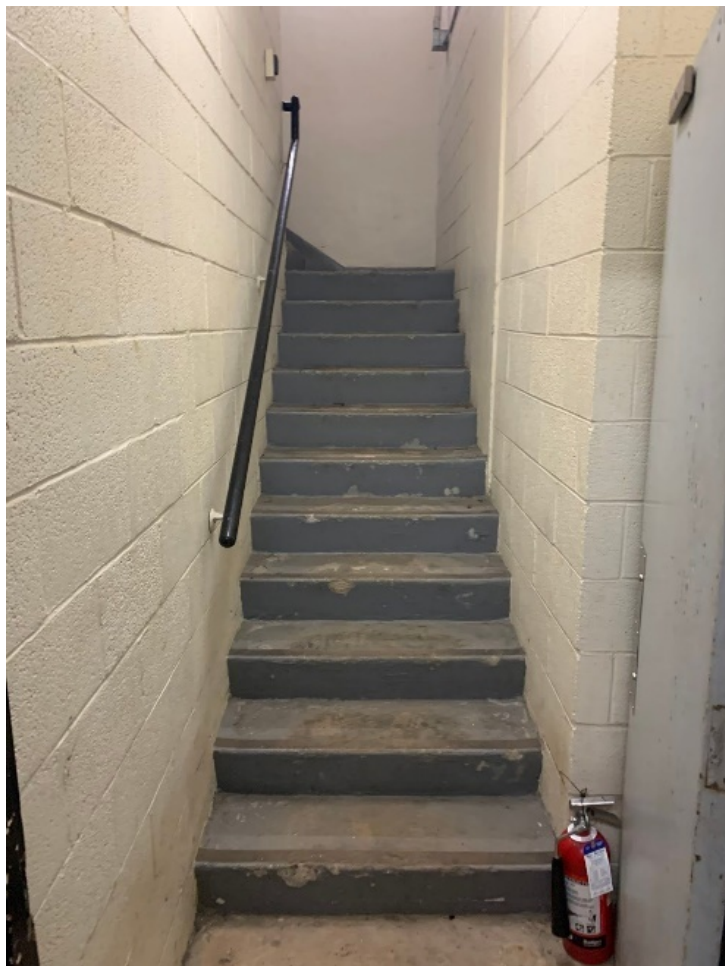
Stairway 2 is a partially cast-in-place concrete and steel pan stair. The lower concrete portion of the stair extends from Level 1 and serves the basement and sub-basement levels. The steel portion serves Levels 2-5 and extends to the roof penthouse. The steel portion of the stair does not meet current building code maximum riser height or minimum riser run. Current handrails do not meet guard or handrail code requirements. Some door swings may need to be reversed to swing in the direction of egress travel.

**Recommendation:** This stair should remain and be utilized as one of two required egress stairs serving the building. The Existing Building Code allows the project to keep the existing stairs despite the riser/run dimensions not meeting current code. While not code required under the existing building code, we recommend replacing the guardrail and handrail assemblies with current code compliant railing for safety.

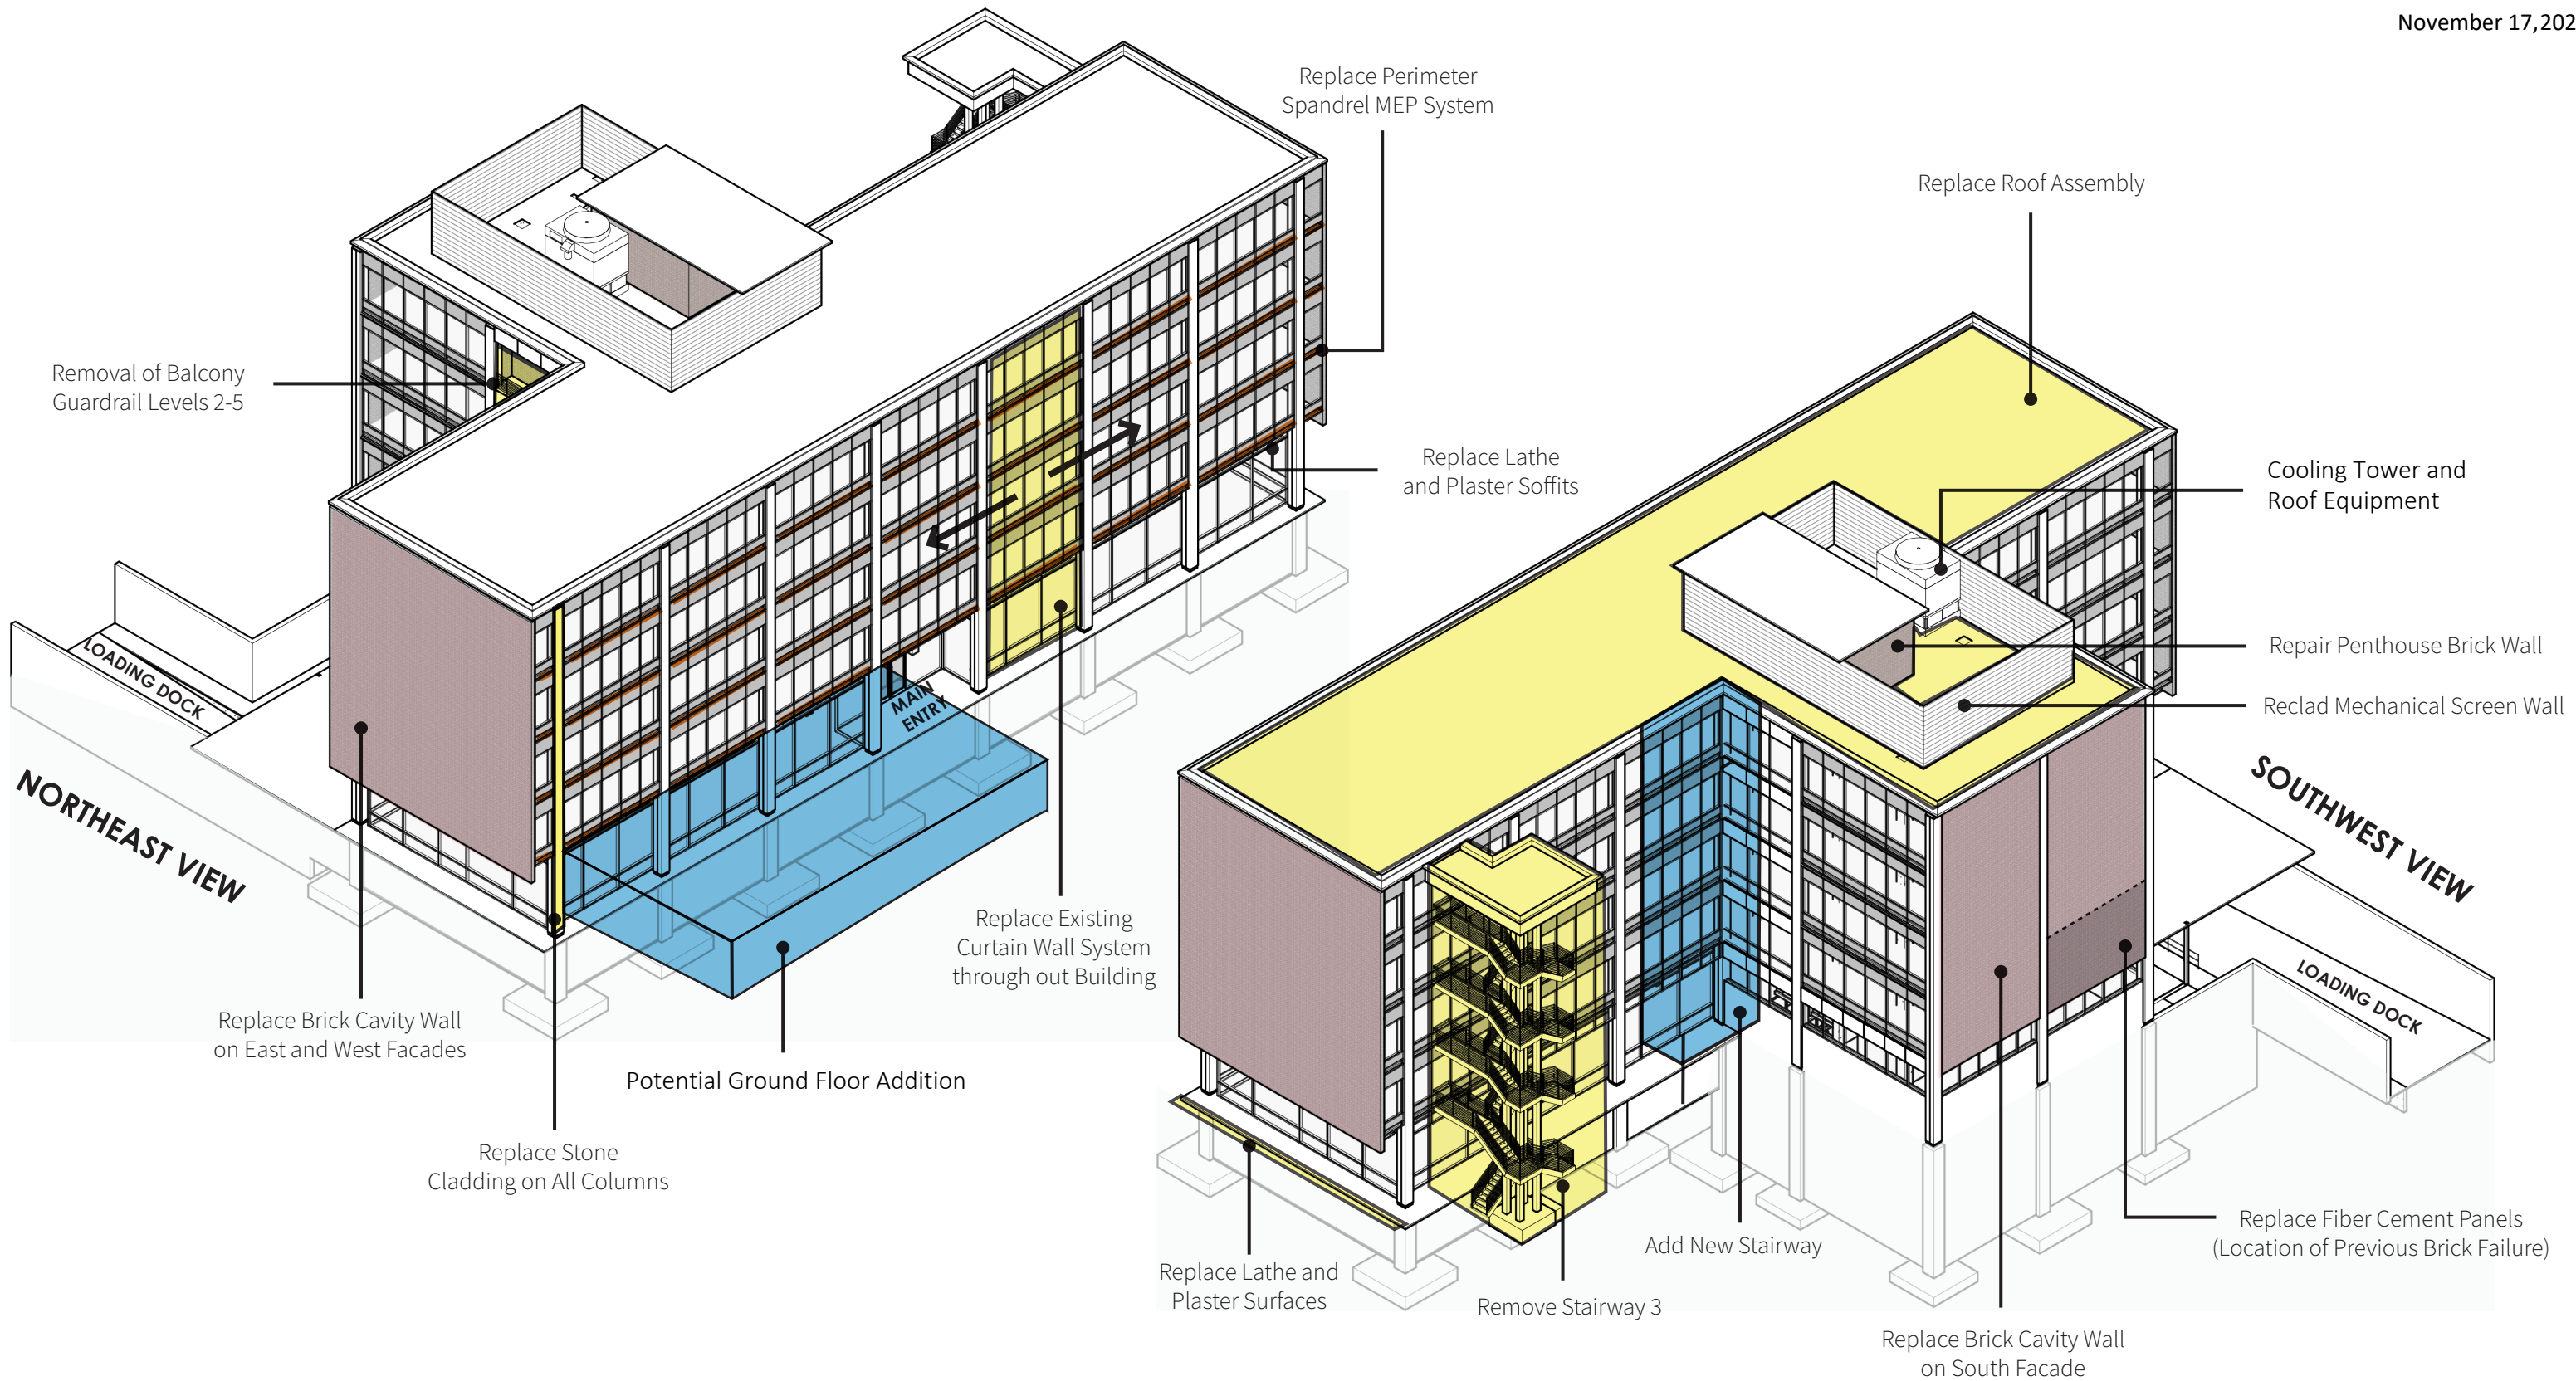
## AXON - EXTERIOR RECOMMENDATIONS

These recommendations serve as an overview of significant exterior repairs. This does not serve as a comprehensive list.

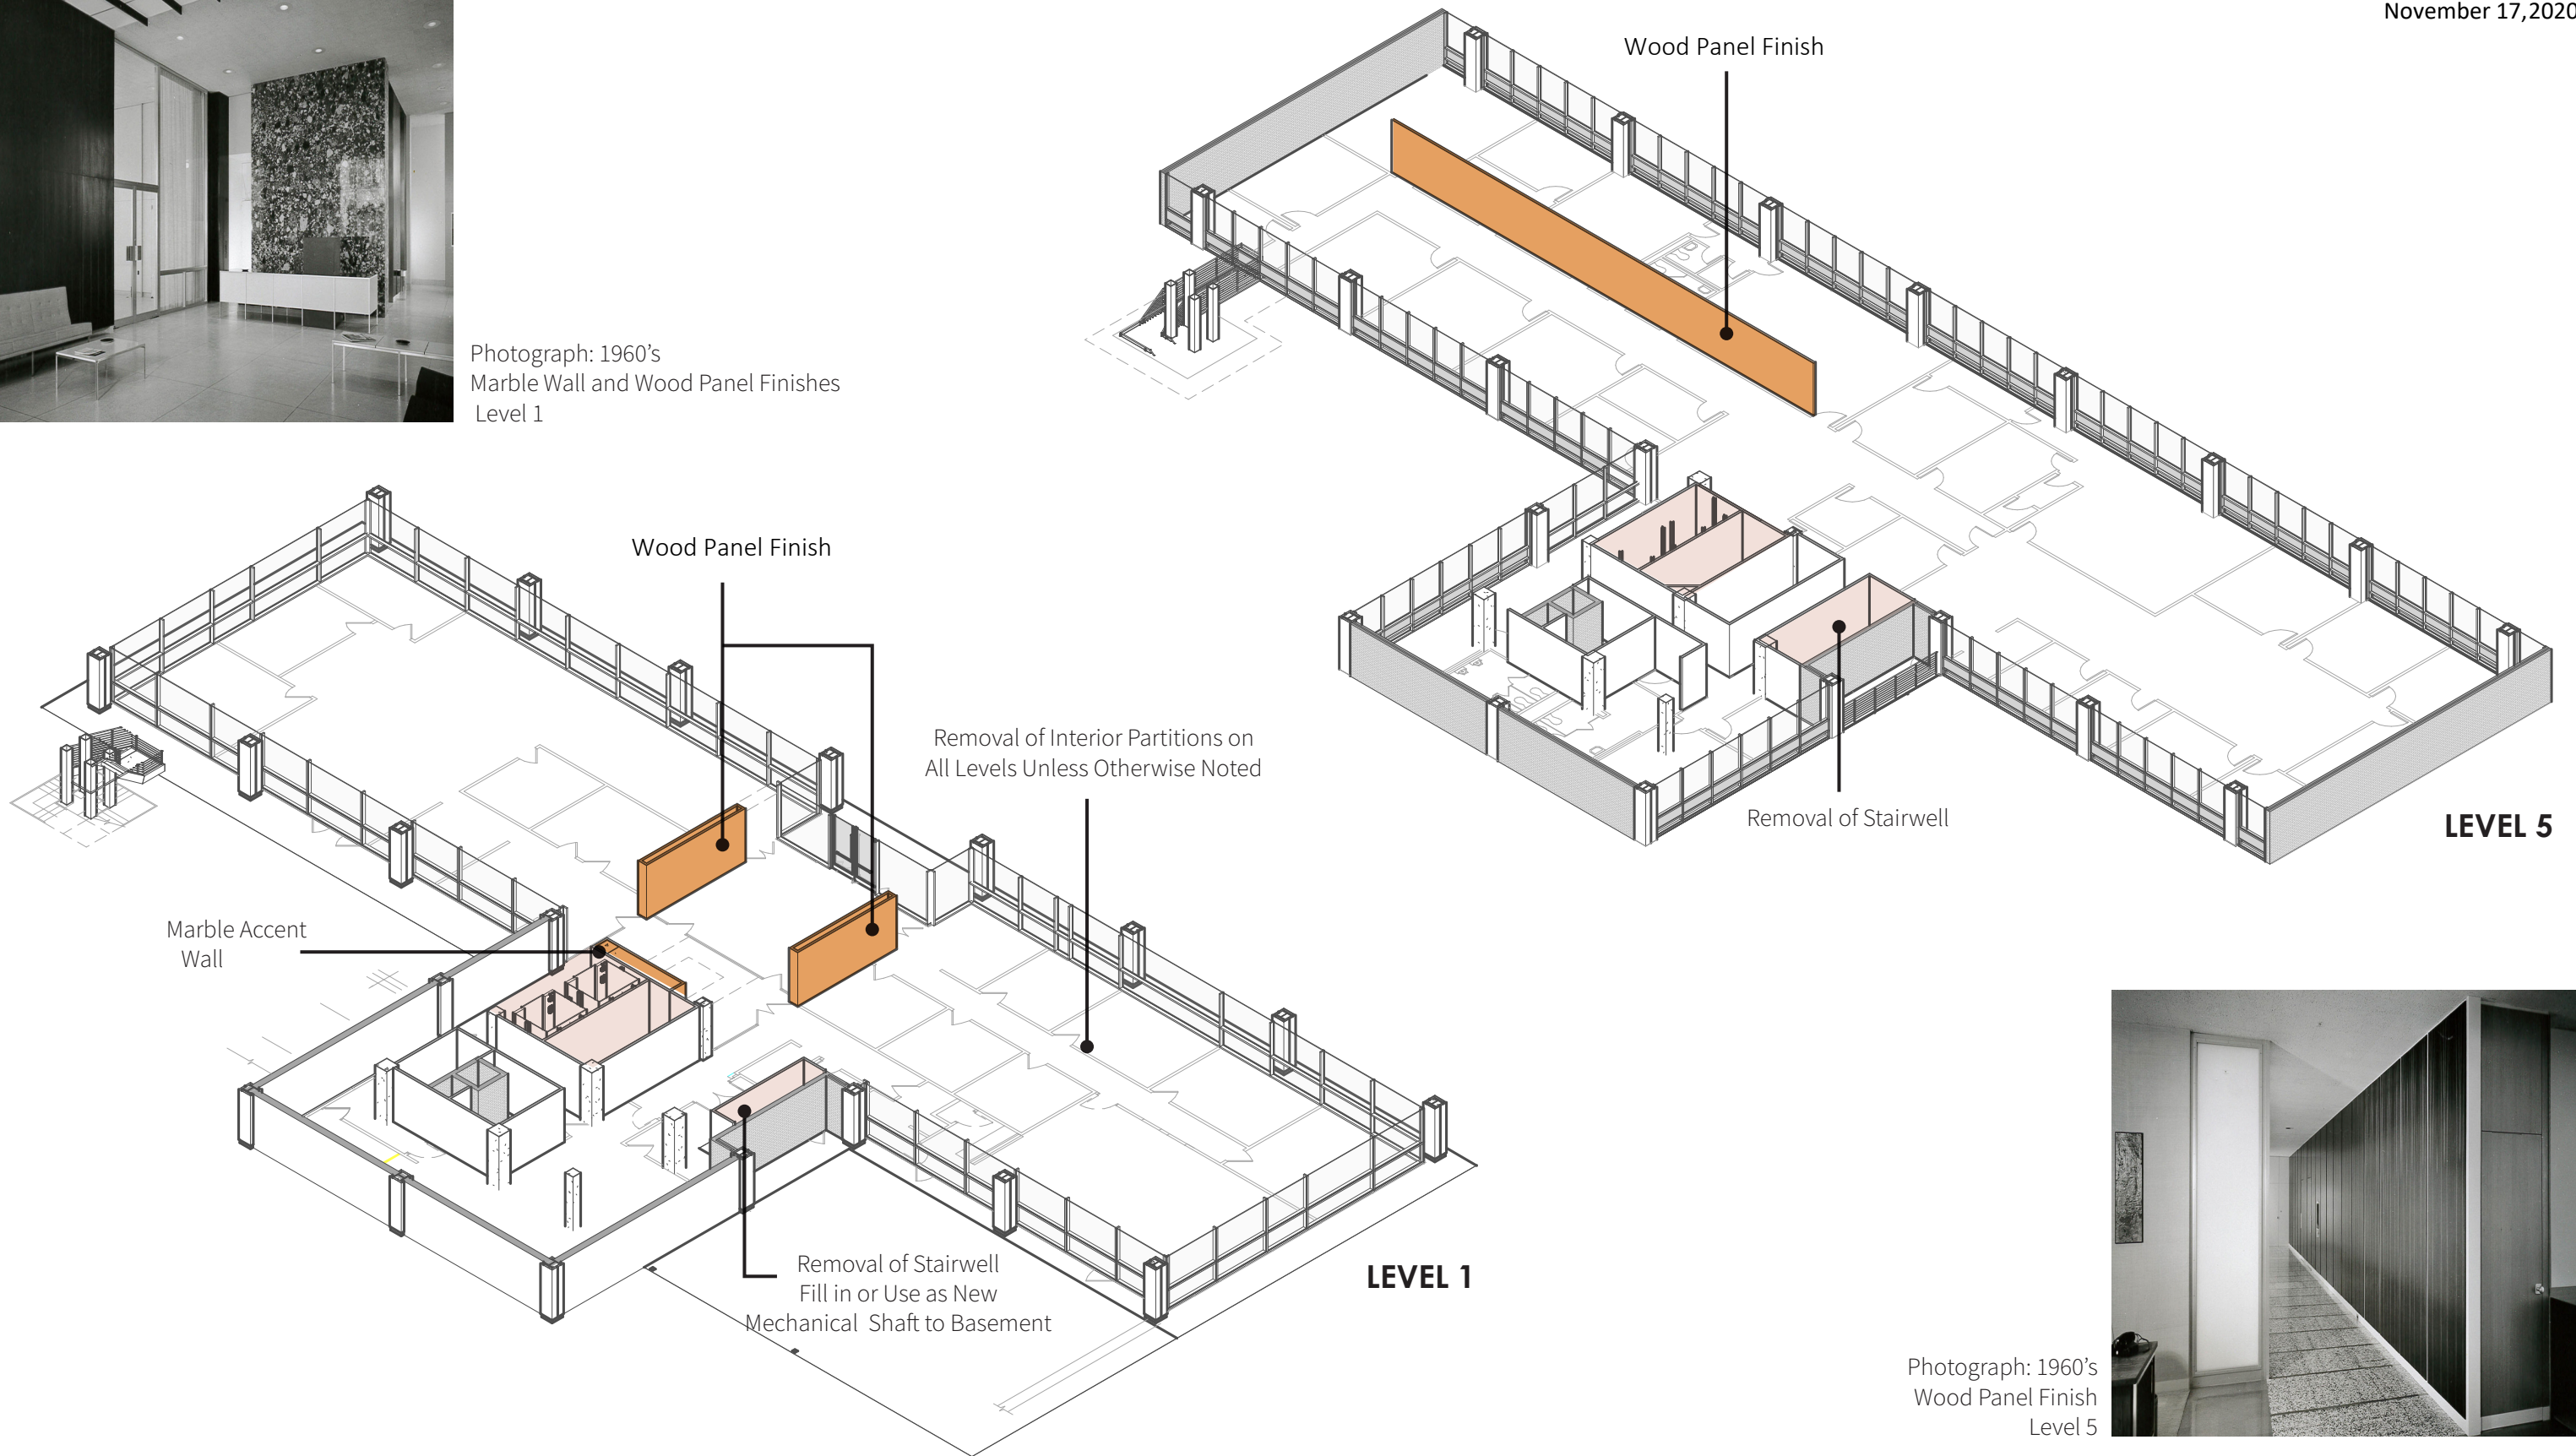
# AXON - ARCHITECTURAL INTERIOR RECOMMENDATIONS

These recommendations serve as an overview of significant interior repairs. This does not serve as a comprehensive list.
